# **Emerald Ridge Area Ground Water Resource Assessment**

**James E. Swierc, PG  
Lewis and Clark Water Quality Protection District**

**March 2014**

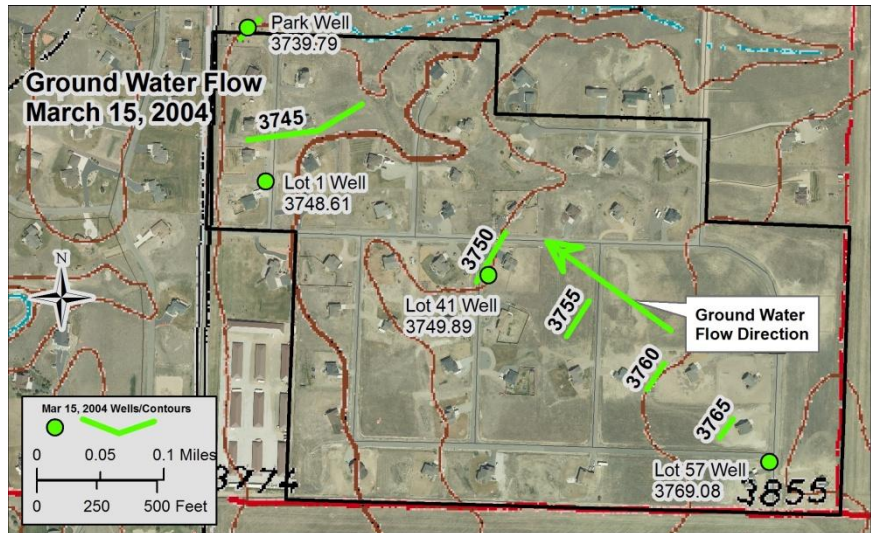
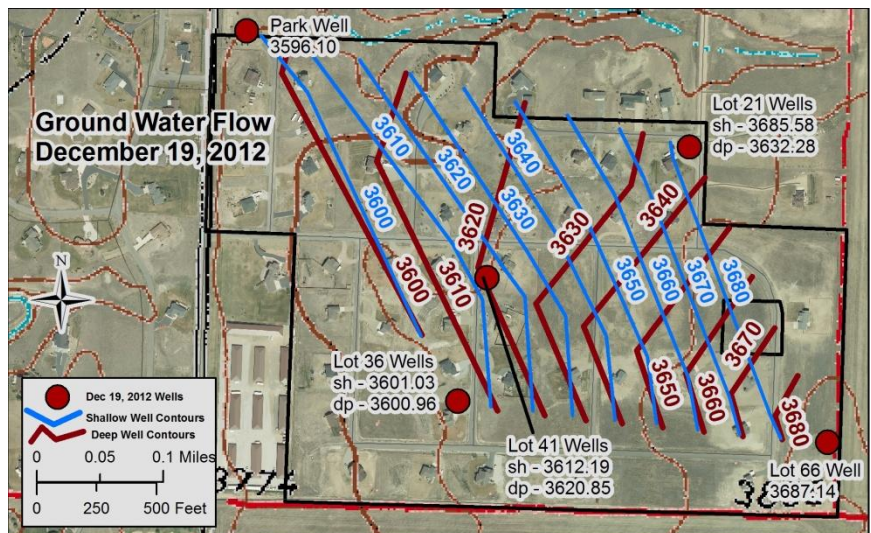
**Figure 2 Emerald Ridge Ground Water Surface March 15, 2004 and December 19, 2012.**

Depletion of the aquifer resulted in homeowners installing deeper replacement wells on 28 lots in the subdivision, as of February 2014, with two homeowners installing third replacement wells. Several of the replacement well depths exceed 700 feet below ground surface. The depletion of the aquifer surface is depicted in Figure 2, which compares the water table surface prior to development in 2004 with the surface in December 2012. The estimated depletion ranges from approximately 100 feet in the southeastern corner of the subdivision, to 150 feet in the northwestern corner. At the time of preparation of this report, approximately seventeen lots were still undeveloped due to the depletion issue (Hiltunen, 2014).

March 2004 ground water data plotted with a 5-foot contour interval.

December 2012 water table surface depicts both shallow and deep well data from Lot 36, Lot 41 and Lot 22; with singles wells at the other two locations. Data plotted with a 10-foot contour interval. Ground water flow direction is perpendicular to flow contours, with both surfaces indicating a generally western flow direction.

Dewatering of water surface visible, ranging from approximately 100 feet in southeast corner, and 150 feet in northwest corner.

The water table surface on March 14, 2004, prior to development of the subdivision, was determined as part of the planning process for the area (Brooke, 2014). Available wells were used to determine the hydraulic gradient across the site as depicted Figure 2. Since the wells are essentially along a line rather than spatially distributed, the results show a gradient between the wells, but may not be representative of the specific flow direction at that time. However, the data is sufficient to indicate that flow is generally to the west or northwest, following topography towards the Helena Valley. The water levels are indicated on the hydrograph in Figure 3, for comparison with current water levels. At that time in 2004, water levels are above the Lake Helena water surface level, consistent with flow to the west towards the Helena Valley.

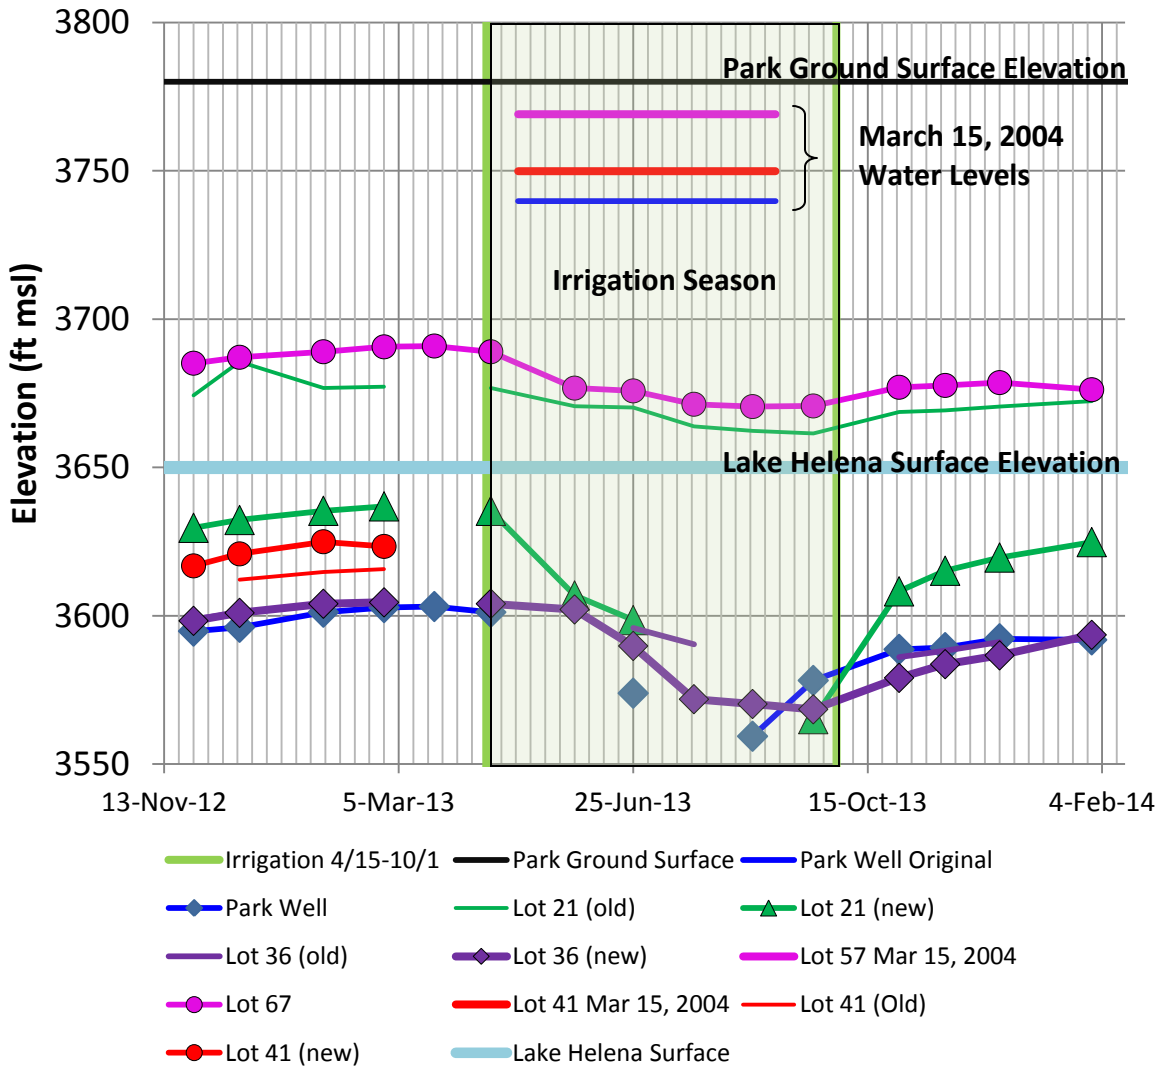
**Figure 3 Hydrograph of Emerald Ridge Water Levels.**

- **Park Well** – the Park well has been utilized for irrigation of the park area at the northwest corner of the subdivision. The well represents the original well for the property, utilized as a pumping well for a pump test to determine the hydraulic properties of the local aquifer. The well is located in a downgradient position near the lowest elevation in the subdivision, and obtains water from approximately 300 to 360 feet below ground surface (ft bgs). The water level indicates depletion of approximately 140 feet over the last 10 years. Drawdown of approximately 40 feet occurred during summer 2013, with no visible recharge peak associated with the beginning of irrigation season. The water level began to recover in Fall 2013; however, the recovered water level appears to be approximately 10 feet lower than during the previous winter. With water levels below the Lake Helena and Helena Valley Aquifer levels, a hydraulic gradient must exist from the valley westward towards this well; however, significant recharge does not appear to be occurring to this location.

- **Lot 21 Wells** – The wells in the northeastern part of the subdivision are installed to depths of 220 feet and 483 feet bgs. At this location, the shallow well draws water from above the screened portion of the Park Well. The hydrograph pattern is different between the deep and shallow wells, indicating that the shallow well receives recharge and draws water from a part of the aquifer that is disconnected from the water bearing interval in the deep well. The difference is the deep well shows a seasonal drawdown with recovery similar to the Park Well. Since it is located on the hillside above the Park Well, the deep well is screened at a similar depth to the Park Well. Based on the summer drawdown and recovery, the deep well is interpreted to be within the same water bearing interval as the Park Well. However, recovery to the previous winter water level does not appear to have occurred.

- **Lot 36 Wells** – The wells on the eastern side of the southern area of the subdivision are installed to depths of 245 and 600 feet depth. While the base of the shallow well is near the top of the water table surface, both wells follow the same seasonal drawdown and recovery behavior as the Park and Lot 21 wells. This suggests that at this location, the upper and deeper parts of the aquifer system are hydraulically connected.

- **Lot 41 Wells** – These wells, located in the central part of the subdivision, are installed to depths of 280 and 696 feet depth. Only a limited number of measurements were taken at these wells, during winter 2012-2013. The hydrograph data show an upward vertical gradient from the deeper well to the shallower well, showing that the two water bearing intervals in the aquifer are separated by an less permeable layer which restricts ground water flow (an aquitard) at this location. Data over the summer irrigation season is not available for this location.

- **Lot 67 Well** – This well is installed to a depth of 356 feet bgs. The hydrograph does not show any significant drawdown during the summer, and follows the same general pattern as the shallow well in Lot 21. This pattern suggests that this well is located within the upper part of the aquifer system. While the water level appears stable, the water levels do not appear to reach the levels from the previous year. In addition, the water level in the well in Lot 57, across the street from this lot, was approximately one hundred feet higher in 2004.

The hydrograph data indicates that the shallower part of the aquifer system is not connected to the deeper part along the northeastern part of the subdivision, but is connected along the southwestern part. Since water levels do not appear to be recovering to similar levels as previous years, continued depletion of the aquifer continues.

Water levels collected monthly by LCWQPD staff since November 2012. Primary aquifer recharge in the Helena area occurs during Irrigation season, from April 15 to October 1. Dewatering of the aquifer is visible with the change in elevation since 2004. The deep wells appear connected to the same aquifer system as the Park well, with similar drawdown patterns. Note no recharge visible from irrigation waters, and recovery levels in Winter 2014 are below levels from Winter 2013.

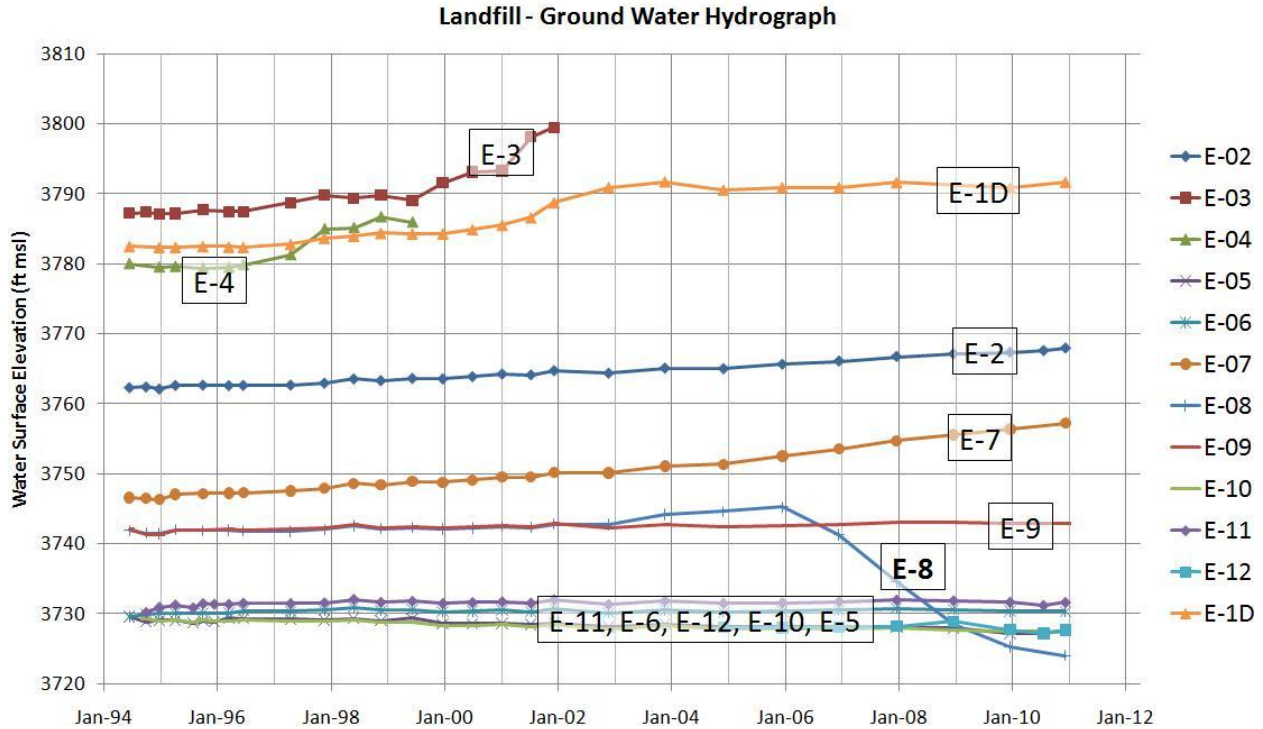
**Figure 4 Hydrograph of Water Levels at Lewis & Clark County Landfill**  
 Data obtained from monitoring report for the Landfill (Tetra-Tech, 2012)

The drawdown of the shallow aquifer is further evidenced by drawdown observed in a shallow monitoring well E-8 on the southwest corner of the Lewis & Clark County landfill, as shown in Figure 4. In this hydrograph of wells, the trend in water level elevations in other wells clearly differs from well E-8.

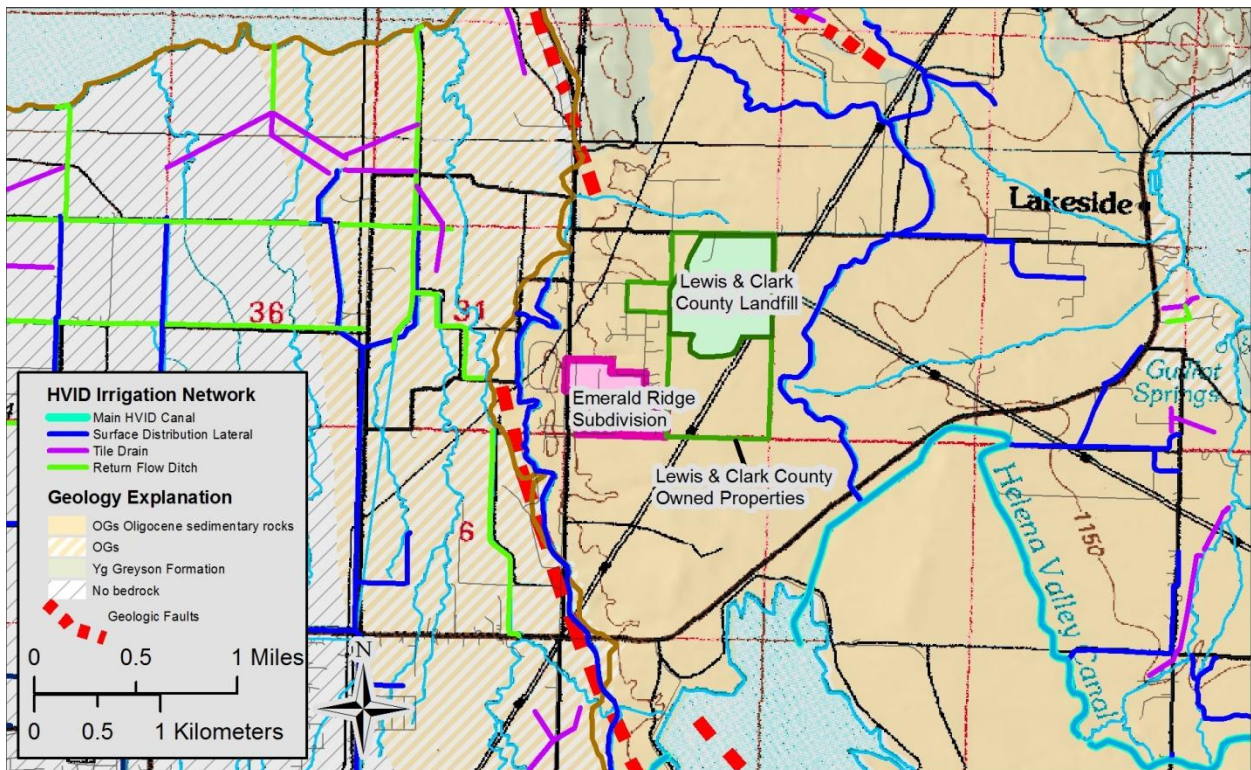
**Figure 5 Emerald Ridge Area Geologic Map.**

The local geology defines the aquifer system and potential recharge paths for the Emerald Ridge area. North-south trending faults are present along the eastern margin of the Helena valley near the site (Figure 5). These faults reflect the geologic processes that formed the Helena Valley. While specific faults are identified near the Emerald Ridge area, the nature of the faults near the subdivision has been approximated. The faults appear to control local ground water flow, including recharge.

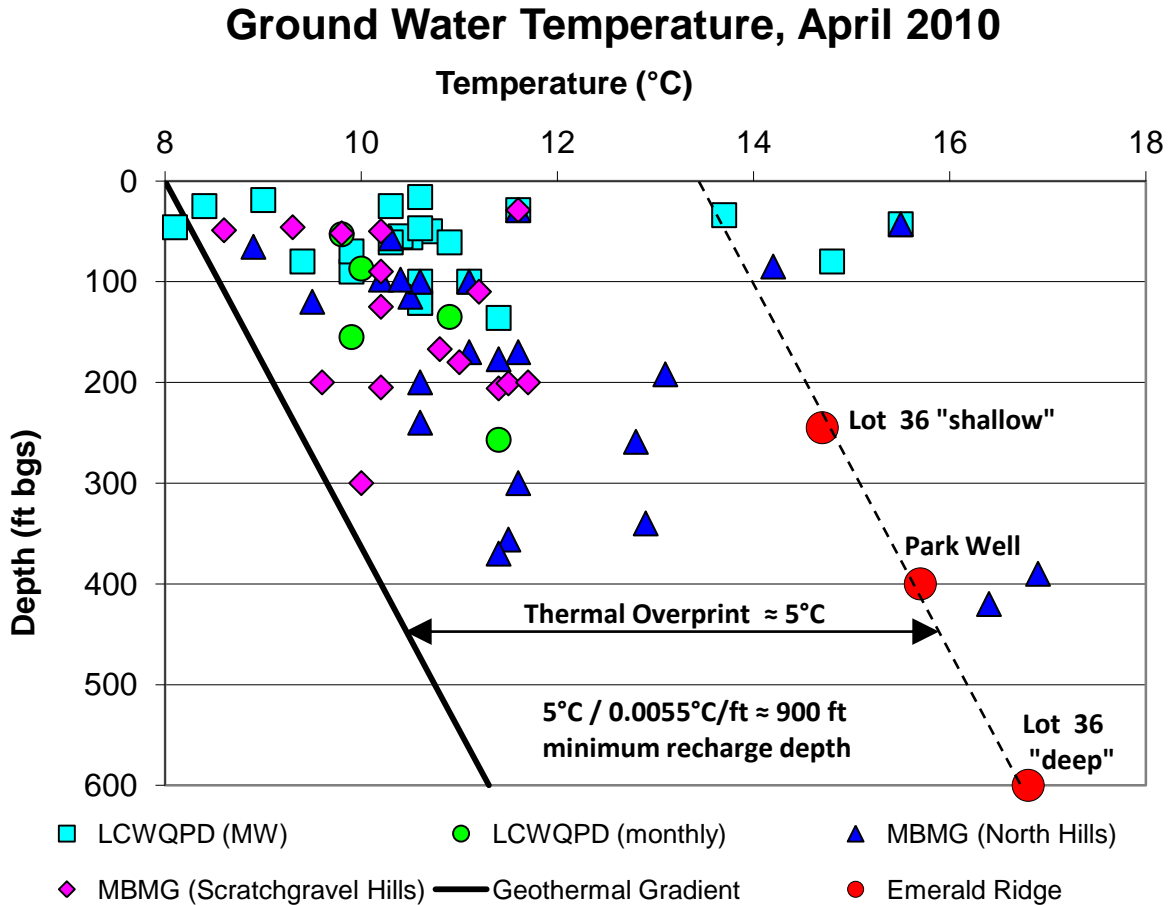
**Figure 7 Emerald Ridge and Helena Valley Ground Water Temperature.**

Ground water temperatures typically are just above the mean normal annual temperature for an area. Near the surface, temperatures will fluctuate seasonally due to thermal heating from the surface, with this effect generally gone by about 75 feet below ground surface (Heath, 1983). Beneath this depth, ground water temperatures increase with depth at approximately 0.55°C/100 feet depth – with this trend referred to as the **geothermal gradient**. Local studies in the Helena area have indicated that valley waters are typically heated above what would be expected by the normal geothermal gradient (Swierc, 2013). From background wells in bedrock wells north and west of the Helena Valley, the general background temperature at the surface is 8°C, with temperatures increasing with depth along the normal geothermal gradient. Ground water temperature data from around the Helena area is depicted in Figure 7, with data from the Emerald Ridge wells. The data shows numerous ground water temperatures above those expected by the normal geothermal gradient. The Emerald Ridge data shows a consistent thermal overprint, with temperatures increasing along the geothermal gradient as expected. This indicates a similar recharge source and connection for the upper and lower parts of the aquifer.

Data plotted from sampling events in April 2010. LCWQPD Samples were collected as part of the Helena Ground Water Project (Swierc, 2013). MBMG data were collected as part of the Ground Water Investigation Program projects implemented in the Helena area, including the North Hills (Waren et al., 2012) and Scratchgravel Hills (Bobst et al., 2013). Data for Emerald Ridge indicates similar recharge source for area based on consistent thermal overprint on what would be predicted at the normal geothermal gradient.
