# Lake Helena Drive - Preliminary Engineering Report

**LEWIS & CLARK COUNTY**

RPA PROJECT No. 09503.000

December, 2009

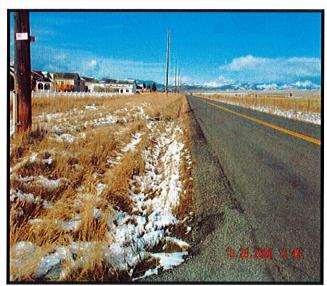
Photo 2: Looking north along Lake Helena Drive north of Canyon Ferry Road.

Lake Helena Drive between Canyon Ferry Road and York Road is very similar in aspects to the section south of Canyon Ferry Road. The primary exception is that both roadside ditches are very shallow, at about 18 inches deep. In this segment, the overhead transmission line and Helena Valley Irrigation Canal lateral running along the west side of the right-of-way are both a continuation of physical features that limit the opportunity for roadside improvements (unless each is relocated). The typical constraints and similarities of both segments are shown in Photo 2 above, and Figure 3, below.

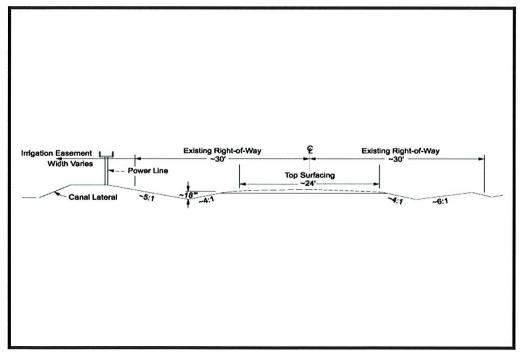
Figure 3: The Existing Section Between Canyon Ferry Road and York Road.

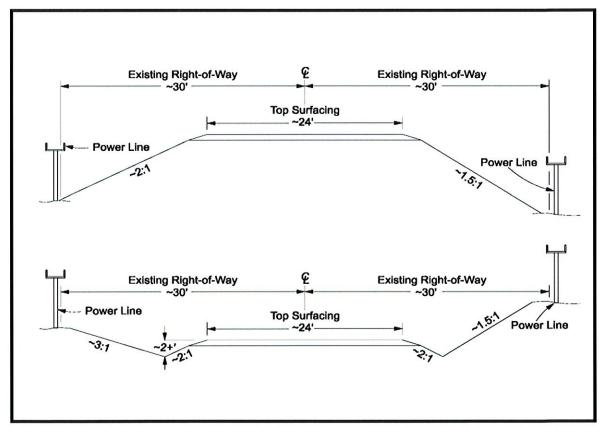
Figure 4 below is a composite diagram showing the typical road width, ditches and cut and fill slopes of the road segment between York Road and Deal Lane. The upper figure represents a typical fill section traversing a drainage, while the lower figure represents a typical section with the profile cutting through the crest of a hill. This portion of Lake Helena Drive is the only segment to have received somewhat recent reconstructive improvements. The reconstruction was completed in 1995 and included new surfacing, adjustments to the vertical profile to improve sight distance, and roadside slope flattening. The efforts completed by the County were to rehabilitate the road in preparation of receiving additional traffic in conjunction of constructing a new solid waste depository adjacent to Deal Lane. With the limited budget reconstruction, the County completed the work to improve the road surfacing while providing roadside safety improvements. As such, grades were improved, but the resultant action required increasing cut depths at the crest of vertical curves, and similarly increasing fill heights to improve sight distance through sag vertical curves. To limit cost, all work was completed to fit the road within the existing right-of-way and limit utility impacts, primarily to the overhead transmission lines running parallel on both sides of the highway. Since improvements were completed to fit within the width constraints of right-of-way and utilities, the cut and fill slope rates adjacent to the travel way, are relatively steep at about a 2:1 in locations, and therefore do not meet current County or AASHTO standards for safety relative to the amount of traffic and travel speeds using the facility. However, where feasible, safety was further improved over its pre-existing condition by installing guardrail barriers in the fill sections.

Figure 4: Representative Cut and Fill Sections of the Paved Section North of York Road

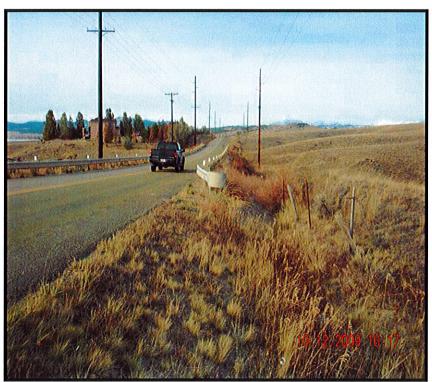
Photo 3: Photo of a cut section transitioning to a fill section through a drainage. Note the guardrail installed for safety. Roadside slopes are steepened to fit within utility and right-of-way limitations.

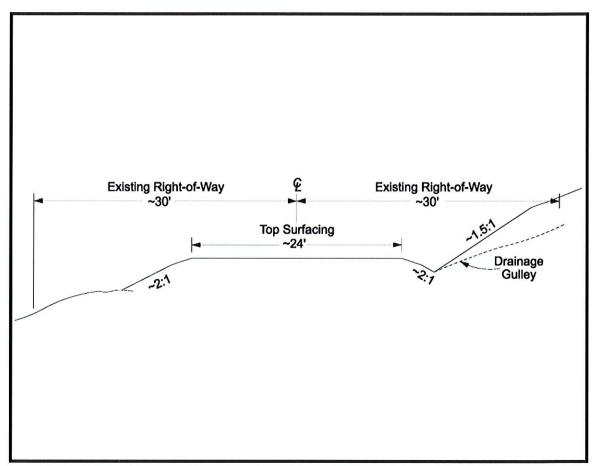
Figure 5: Typical Sectional Characteristics of the Gravel Road North of Deal Lane.

The gravel road is currently signed for a regulatory speed limit of 35 mph to account for the changing conditions that a driver can experience on a gravel road. The road for the most part is maintained to hold as wide as a surface width as attainable to fit within the hillside cut and fill slopes. However, in between surfacing blade and reshaping operations, the gravel surfacing displaces from the traveled way to the ditch or fill slopes. This creates what appears to be a wider road void of gravel surfacing. In its prime condition, the road is approximately 24 feet wide, with about 18-inch deep ditches. The cut slopes are generally characterized as steep at about 1.5:1. The cut slope is somewhat steeper in locations where the road traverses through exposed bedrock. Fill slopes are similarly steep compared to the County's current standards. The overall width of the road from the toe of fills to the top of cut sections is generally built to fit within the allowable right-of-way as shown in the Figure 5 depiction, and it's accompanying representative Photo 4.

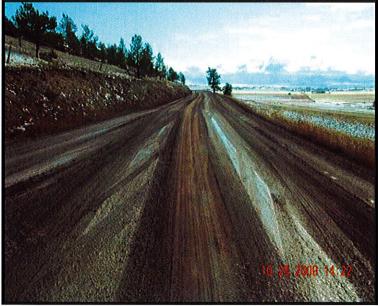
Photo 4: The width of the gravel road can vary depending on gravel displacement. Cut and fill slopes are steep relative to the proximity of the driver.

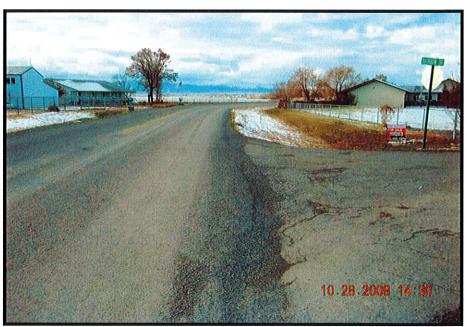
Photo 5: The segment of road north of the causeway exhibits some desirable roadside geometrics.

The short segment of road from the causeway north to the intersection of Lincoln Road is deteriorated having been blade patched numerous times. However, this segment contains some desirable roadside geometrics. As shown below in Photo 5, this section of the project exhibits the flattest ditch slopes throughout the study area even though it has the lowest posted regulatory speed limit of the project at 25 mph. Given the flat roadside slopes and low travel speeds, this segment generally provides the best opportunity for an errant vehicle leaving the road to make a safe recovery. Although the ditch slope rates are favorable, the depth of the ditch would desirably be increased which would provide good cover depth over approach drains. However, there is little opportunity to do so due to the built up housing and Lake Helena limiting the potential to widen the right-of-way. As such, for the purpose of this study, given the very low operating speed and relatively good roadside recovery area, we believe the reconstructive effort in this segment would be focused on reconstructing the road surfacing, and not on the geometrics of the road.

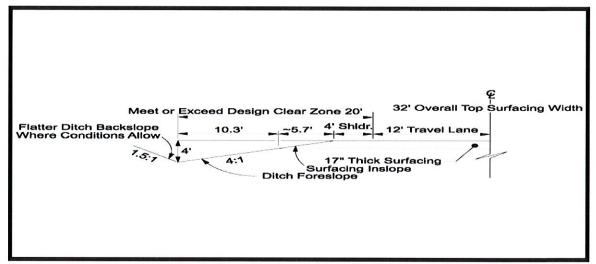
The following **Figures 6** and **7** display the recommended road design typical sections to reconstruct Lake Helena Drive north of the Eastgate subdivisions. Figure 6 is representative of Lake Helena Drive south of York Road, and Figure 7 is the road section north of York Road. Each typical section is based on the design methodology previously discussed in which the County Road Standards served as the basis supplemented by AASHTO guidance as needed. They are very similar with equal travel lane and shoulder widths. The most notable difference is the greater clear zone required for a 50 mph design speed as compared to a 40 mph design speed.

Figure 6: Proposed Road Template for Lake Helena Drive South of York Road

To estimate earthwork and miscellaneous other feature impacts to reconstruct the roadway, we applied the design typical sections, shown in Figures 6 and 7 over the existing road templates as shown in previous Figures 2 through 5. The superimposed design placed over the existing road yielded **Figure 8**, below. The estimate is based on the reconstruction closely following the existing horizontal and vertical alignments.

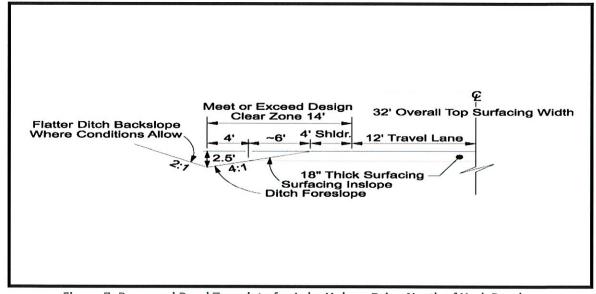
Figure 7: Proposed Road Template for Lake Helena Drive North of York Road.

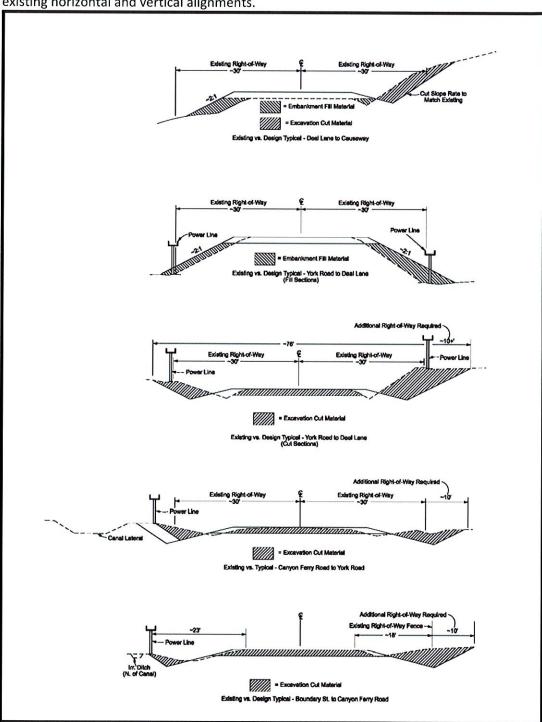
Figure 8: Estimated Cut/Fill Impacts to Reconstruct Lake Helena Drive

**Figure 8** shows representative cut and fill impacts anticipated to reconstruct Lake Helena Drive from south (shown on the bottom) to north (shown at the top) to minimum standards.

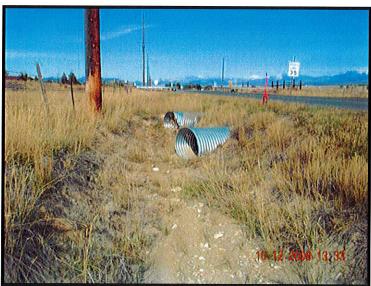
Photo 6: Double culverts installed just south of the Helena Valley Canal, MP 1.6.

From the beginning of the project to York Road, MP 0.0 to 4.0, the existing road traverses level terrain following the direction of the south-to-north natural drainage patterns. As such, the primary hydraulic conveyance feature in the more urbanized area within the Eastgate subdivision, from MP 0.0 to MP 0.5, consists of sheet flow along the edge of the sidewalk. There is no curb and gutter or storm drain system in this location. The sidewalks end north of MP 0.5 and the runoff enters roadside ditches at this point. Flowing northerly, the County installed a cross-draining culvert at approximate MP 1.2, and double culverts nearer to the Helena Valley Canal at about MP 1.6. These three culverts are 42" x 28 ½" corrugated metal arch pipes; each about 56 feet in length. These drains divert the runoff approaching the canal to the east under the road to drain into the agricultural fields.

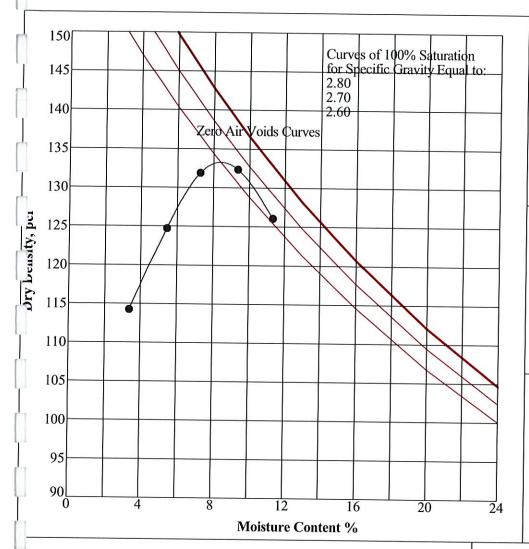
P-8

ASTM D 698 Method C

Maximum Dry <u>Density</u>, pcf

Project No.: 09-2560 Lewis and Clark County Roads Helena, Montana **PROCTOR**

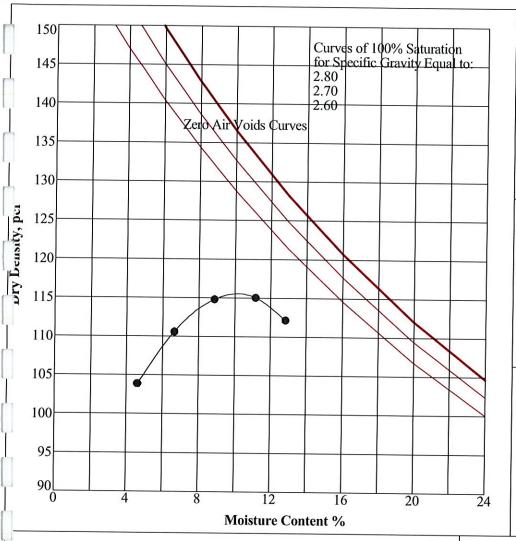
P-9

ASTM D 698 Method C

Maximum Dry <u>Density</u>, pcf

**PROCTOR**
