# North Montana Avenue (North of Lincoln Road) – Preliminary Engineering Report

**LEWIS & CLARK COUNTY**

RPA PROJECT No. 09503.000

# Supplement to the 2009 North Montana Ave. (North of Lincoln Road) Preliminary Engineering Report

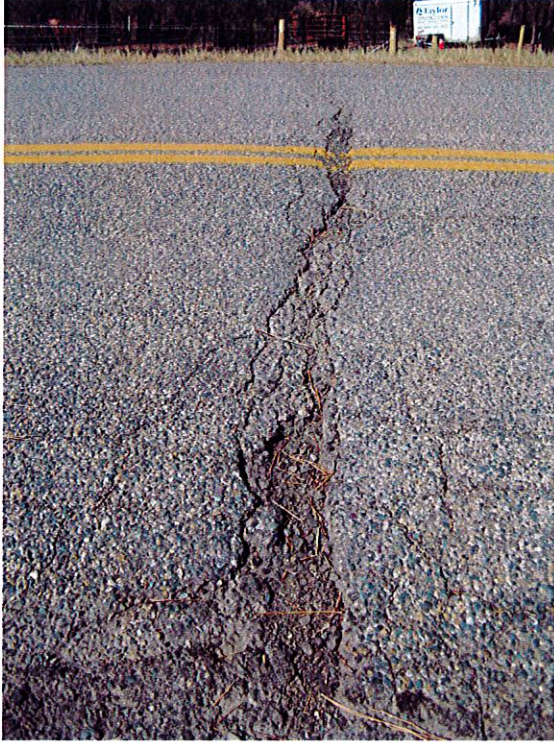
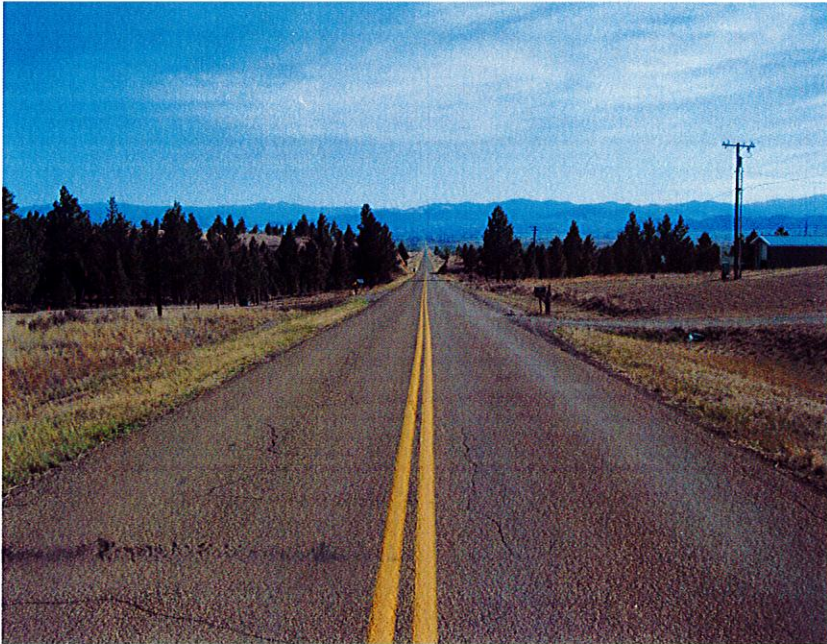
This second surfacing rehabilitation technique identified in this report is to mill the existing surfacing prior to placing a hot plant mix asphalt overlay. The intent would be to mill to a depth to remove superficial cracks. This then would limit crack sealing quantities. However, the existing asphalt surfacing is also experiencing some moderate to significant cracking. This is exemplified in the photos on the following page. Milling will not address significant cracks shown in the upper photo. These significant cracks should be saw cut and patched prior to overlay.

Milling prior to overlay also provides the additional benefit of re-establishing the highway crown by removing ruts. The milling technique may however encounter limitations on this specific project. The existing road surfacing is likely a composite of the original surfacing with multiple blade patches and chip seals. These layers of material could instead break up and fragment during the surface milling operation. The other limitation is the depth that the milling could be accomplished. Based on Table 1, the milling may only be able to remove up to 2 inches of
