# **Emerald Ridge Area Ground Water Resource Assessment**

**James E. Swierc, PG  
Lewis and Clark Water Quality Protection District**

**March 2014**

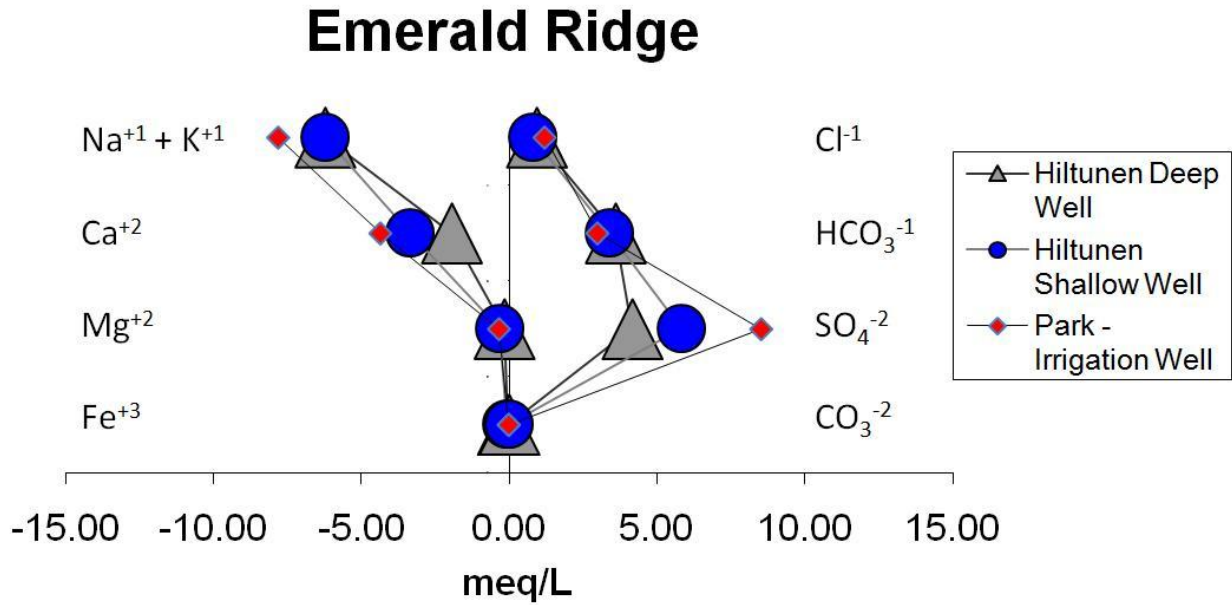
**Figure 6 Stiff Diagram of Major Ions in Emerald Ridge Ground Water.**

The stiff diagram shows relative proportions of major ions as milliequivalents reflecting the total ionic charge from each compound. The total size of the polygon reflects the concentration of Total Dissolved Solids in the sample.

The Tertiary aquifer water quality type for the Emerald Ridge subdivision aquifer indicates that direct recharge does not occur from local streams or irrigation waters. While local precipitation may infiltrate into subsurface within the subdivision, this is not considered likely to be a significant recharge source to the deeper aquifer due to the fine-grained nature of the soils and geologic units in the area. Ground water temperature provides additional information indicating that recharge to the local depleted aquifer occurs from depth, likely in the deepest part of the Helena Valley. This is consistent with the local regional conceptual model of ground water flow, where all ground water upwells towards Lake Helena as a discharge point for both surface and ground waters in the valley (Briar & Madison, 1992; Thamke, 2000).
